O & M INSPECTION REPORT FOR NAVIGATION PROJECTS  
Honolulu Engineer District  
CEPOH-EC-T

1. Project Name: Kawaihae Small Boat Harbor

2. Date of Inspection: June 29, 2007

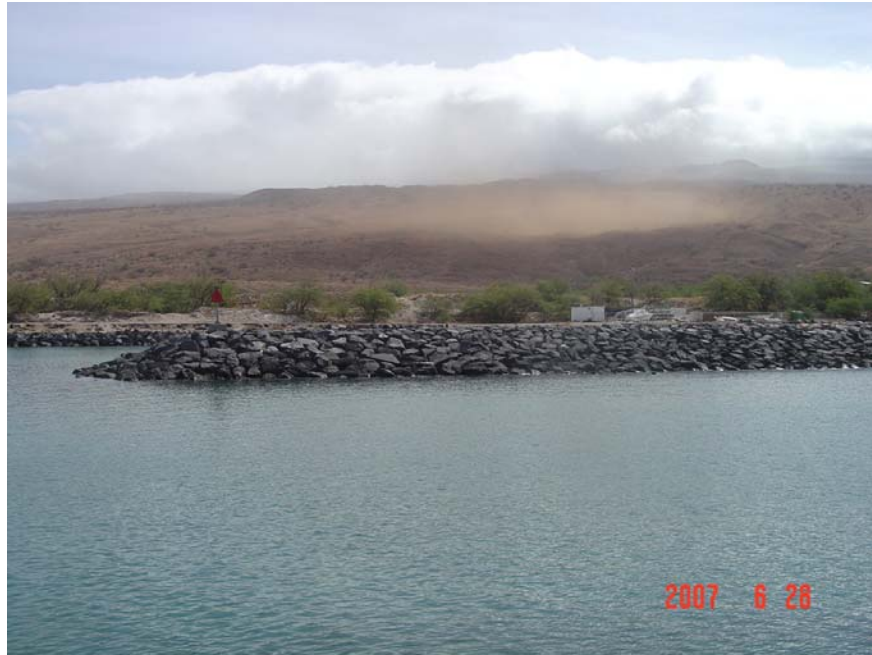
Sta 12+60, Head of East BW. Some settling of armor stones at the head since previous inspection.
